HISTORICAL SUMMARY REPORT
OF
MAJOR ICBM CONSTRUCTION

ATLAS "F"

HISTORICAL SUMMARY REPORT OF MAJOR ICBM CONSTRUCTION

12 ATLAS "F" ICBM COMPLEXES

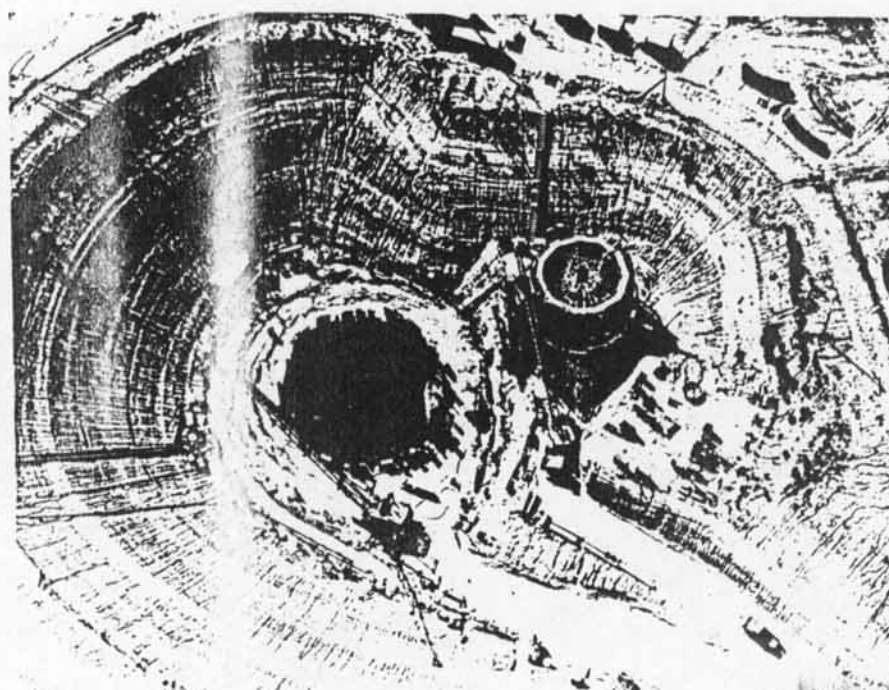
#41304. SITE 8, SEWARD. 11 Oct 60. Aerial view looking west. Note sheet piling around cilo. Work platform is in place around top of LCC in preparation for wall pour.

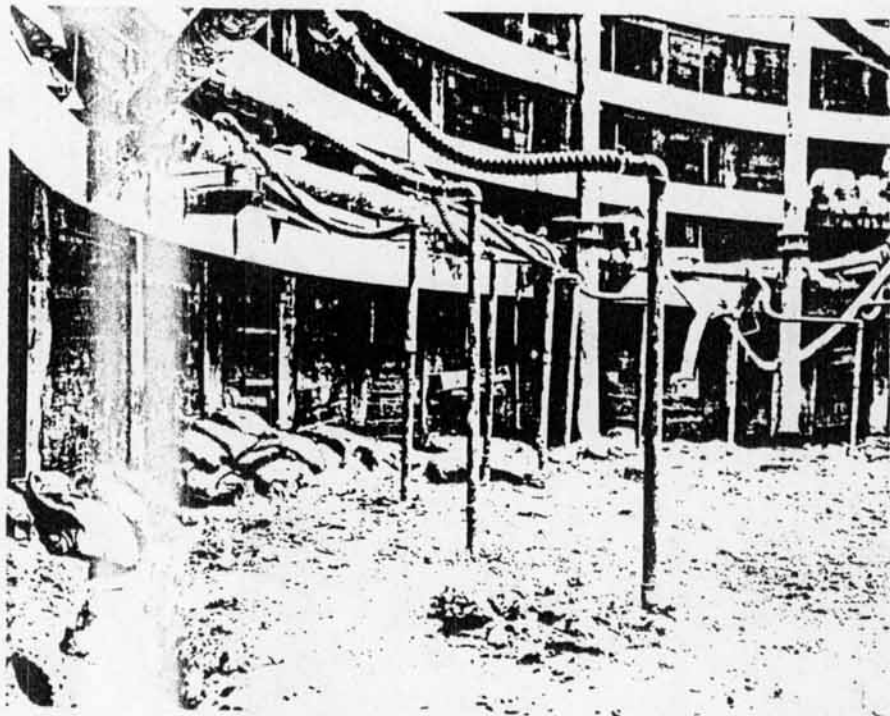
Photo. SITE 8, SEWARD, NEBRASKA. Shows closeup of well points and flexible connections to manifold.

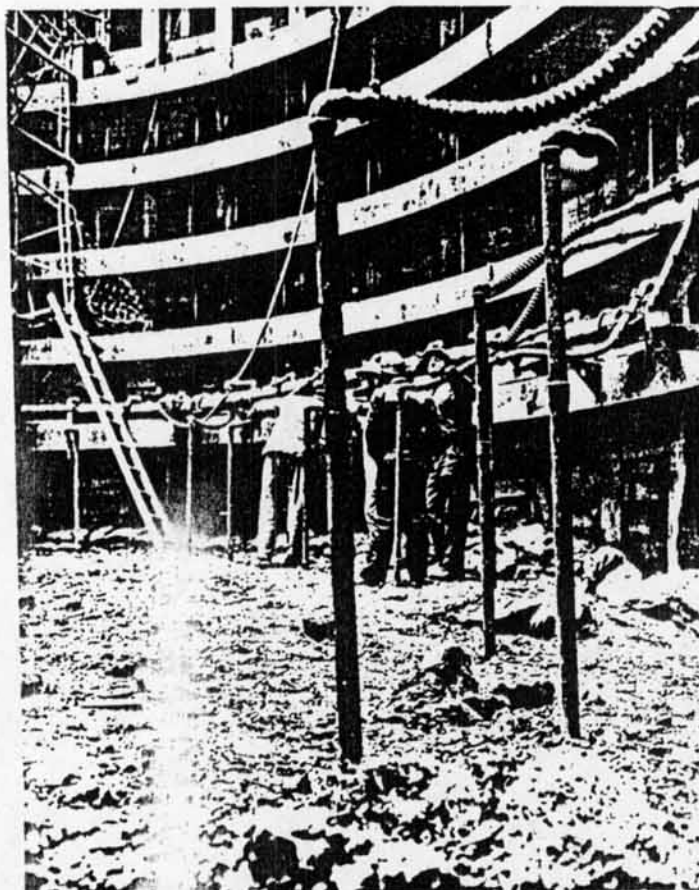
WCC Photo.
SITE 8. BEHARR.
Closeup view
of well point
system. Ladder
and sectional
scaffolding
provide access
to surface.

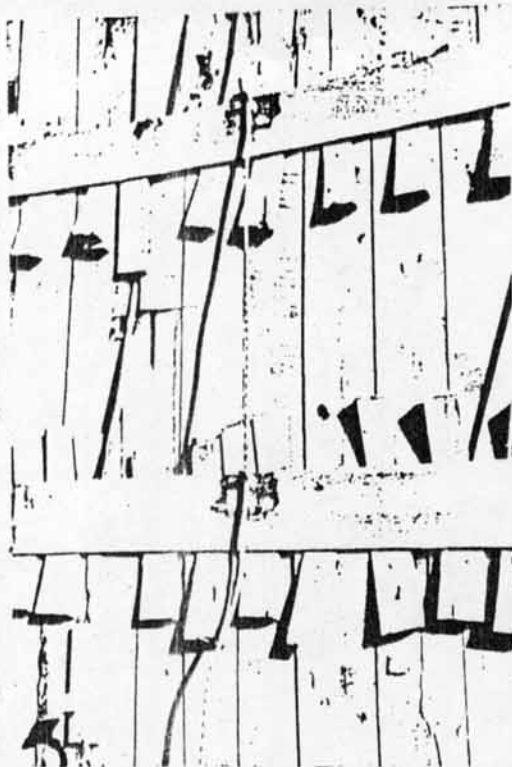
#C-7. Nov. 60. Close-up of ring beam structure shows manner in which oak wedges were used to secure the oak lagging behind the ring beams. Wedges were held with 50 & 60d nails. Note grounding cable attached to ring beams by exothermic welding process. Grounding lug at lower left. Wedges typical all sites using lagging.

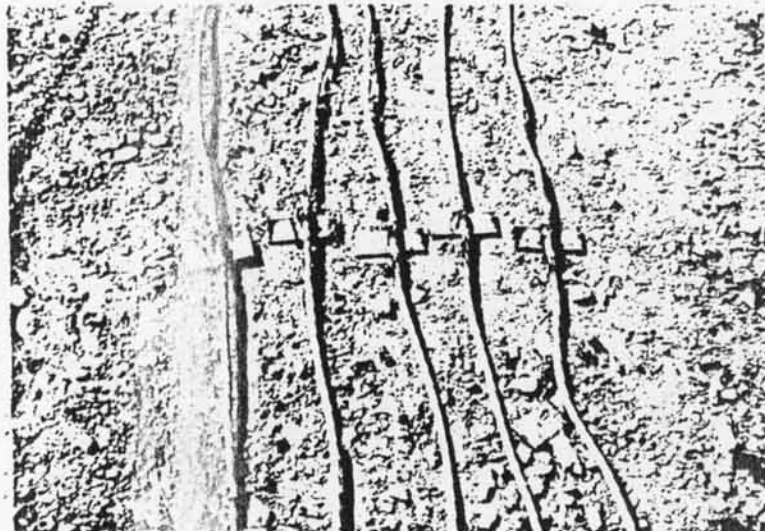
Lower view shows steel plates attached to copper grounding cables by exothermic process. The steel plates were then welded to ring beams and other structural members as required.
